TECHNICAL BULLETIN

CHASSIS GALVANIZING

Doc No: TB-080

Date: 15-Jan-19

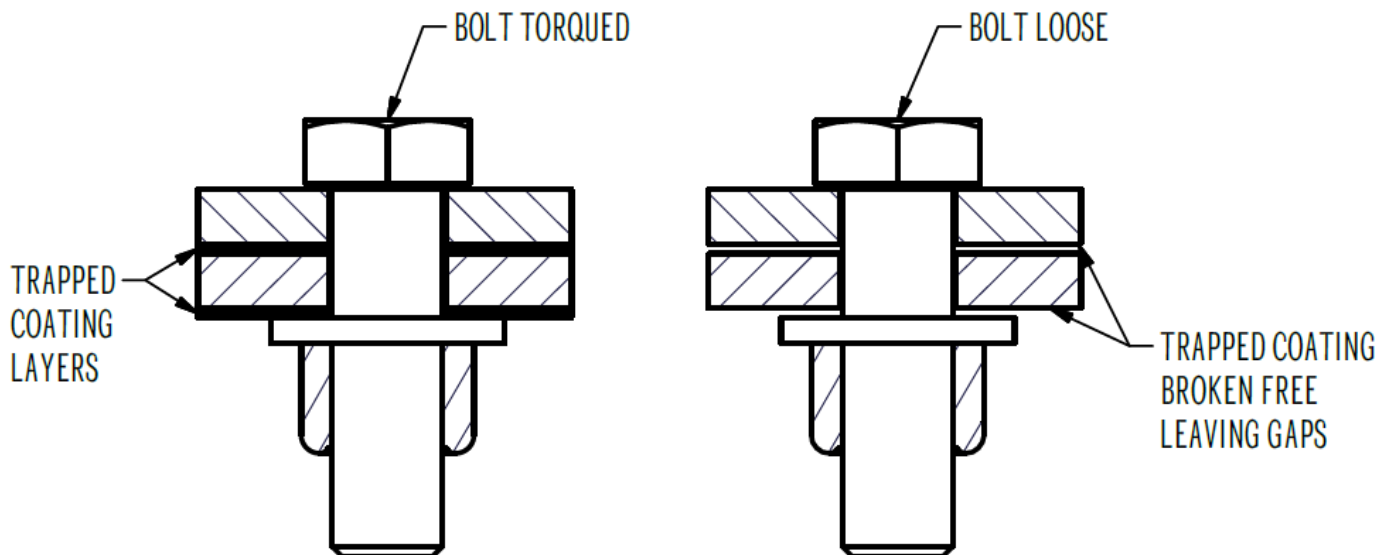
Thick protective chassis surface coatings are clamped under towing components when they are bolted onto the chassis. Trapped coating will initially give the impression that the bolt is torqued but over time the layer will break free and release the clamp load in the bolted connection.

FIGURE 1: Cross-section of component bolted to chassis with trapped coating.

All chassis surfaces used in bolted connections that require to be torqued **MUST be cleaned of excessive coating prior to component assembly.** It is recommended that all bolted connections on new assemblies are torque checked after the first 300km and then after 1000km.

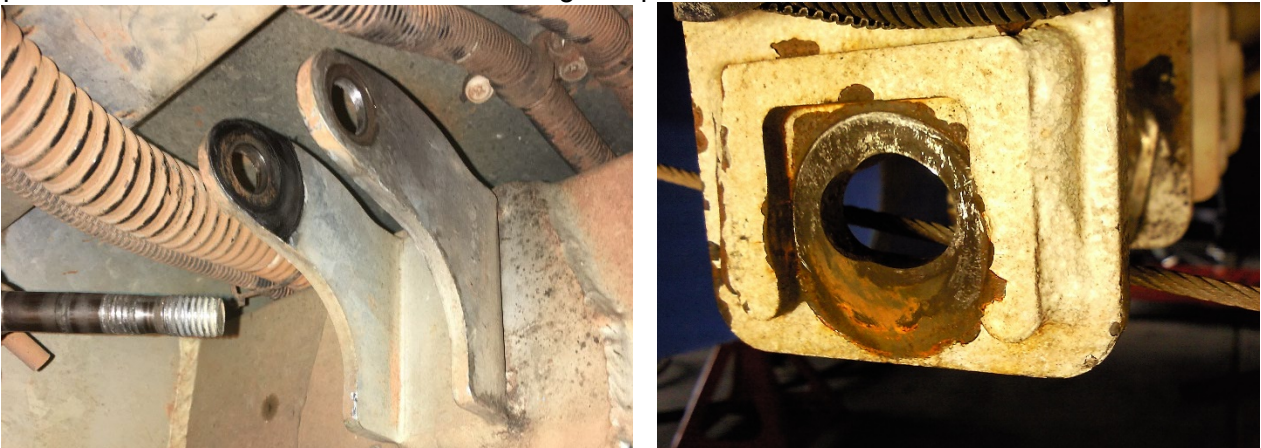
Bolted connections rely on the clamp load induced by the correct torque. Insufficient torque or loss of clamp load will result in the connection loosening and potential failure of the attached component.

FIGURE 2: Loss of clamp/insufficient torque in shock bolts damage the mounts.

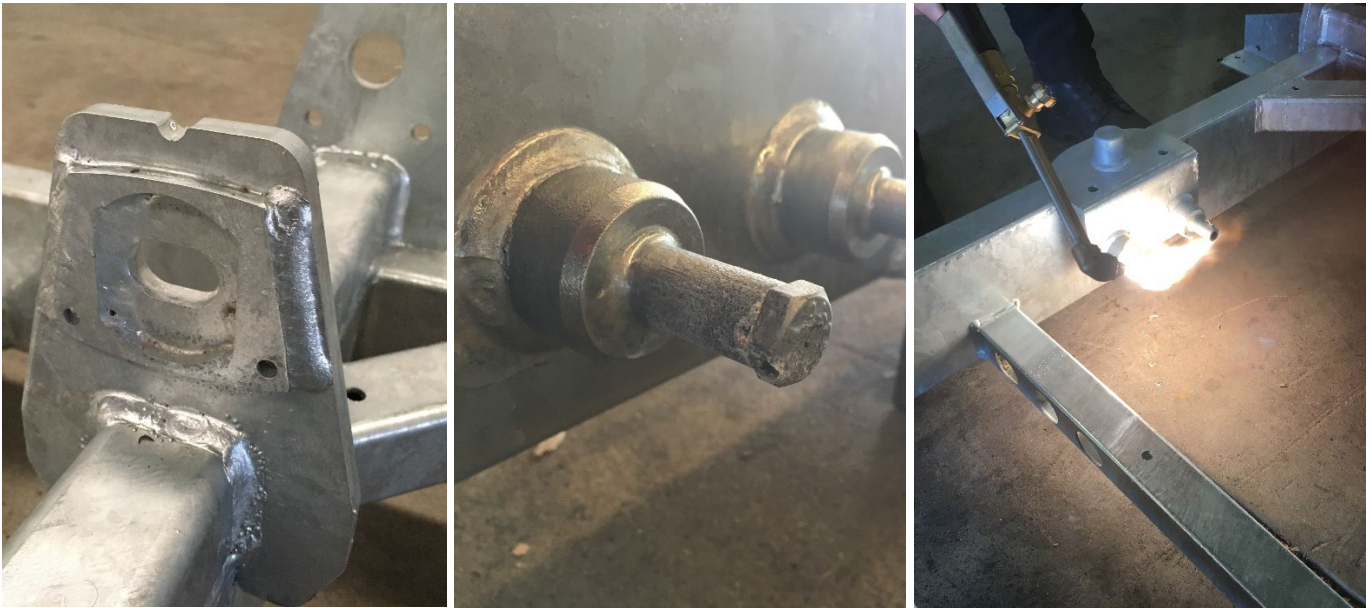
FIGURE 3: Buildup of gal coating on suspension mounts cleaned using heat
